## Inspector's Daily Report

IDR Sheet	1	of	11	Sheets
Contract	Day				Date
C-7852	Thursday				August 12, 2010

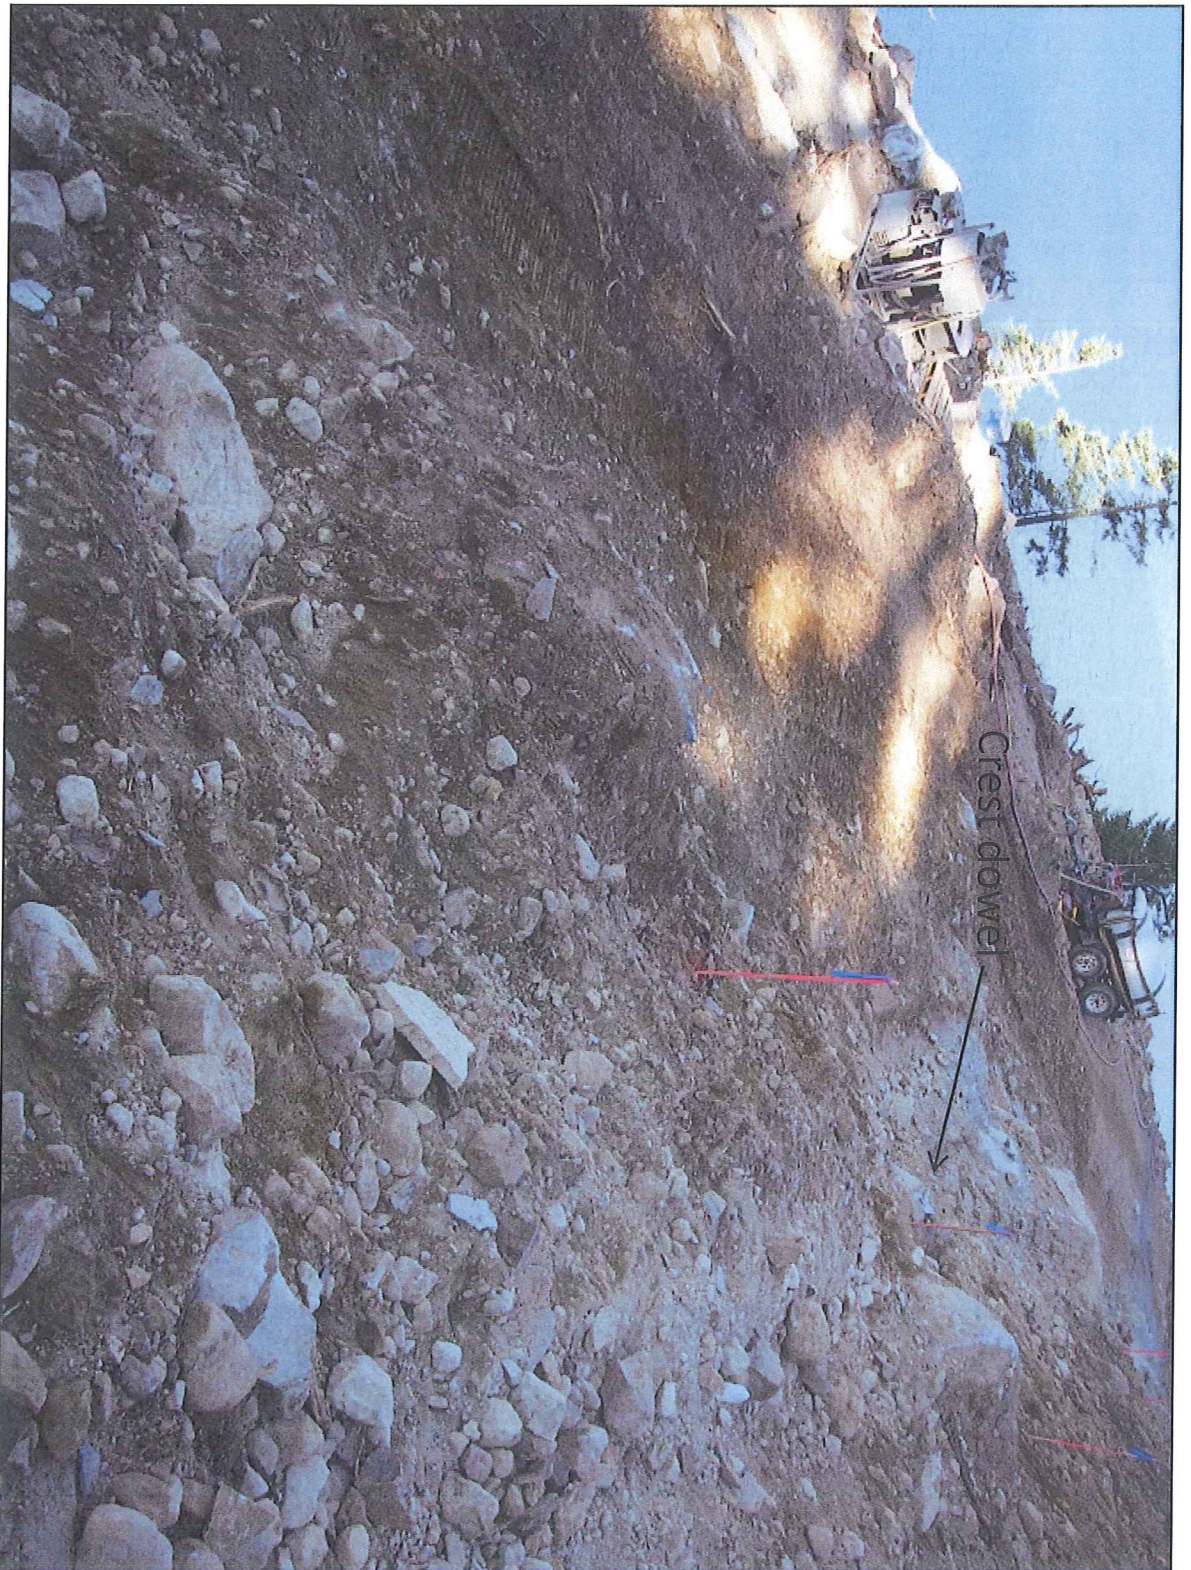
I arrived at the project site around 8:00 a.m. Brad Schut requested help marking crest dowel locations between Stations 1333+00 and 1333+50 because he was having difficulty locating top-of-bedrock. After inspection, I agreed with him that there was still significant overburden between these stations (Figure 1). I recommended that he use an excavator to expose the top-of-bedrock so the crest dowel locations could be marked.

Figure 1: Looking west, Stations 1333+50 to 1333+00. Overburden/bedrock slope.

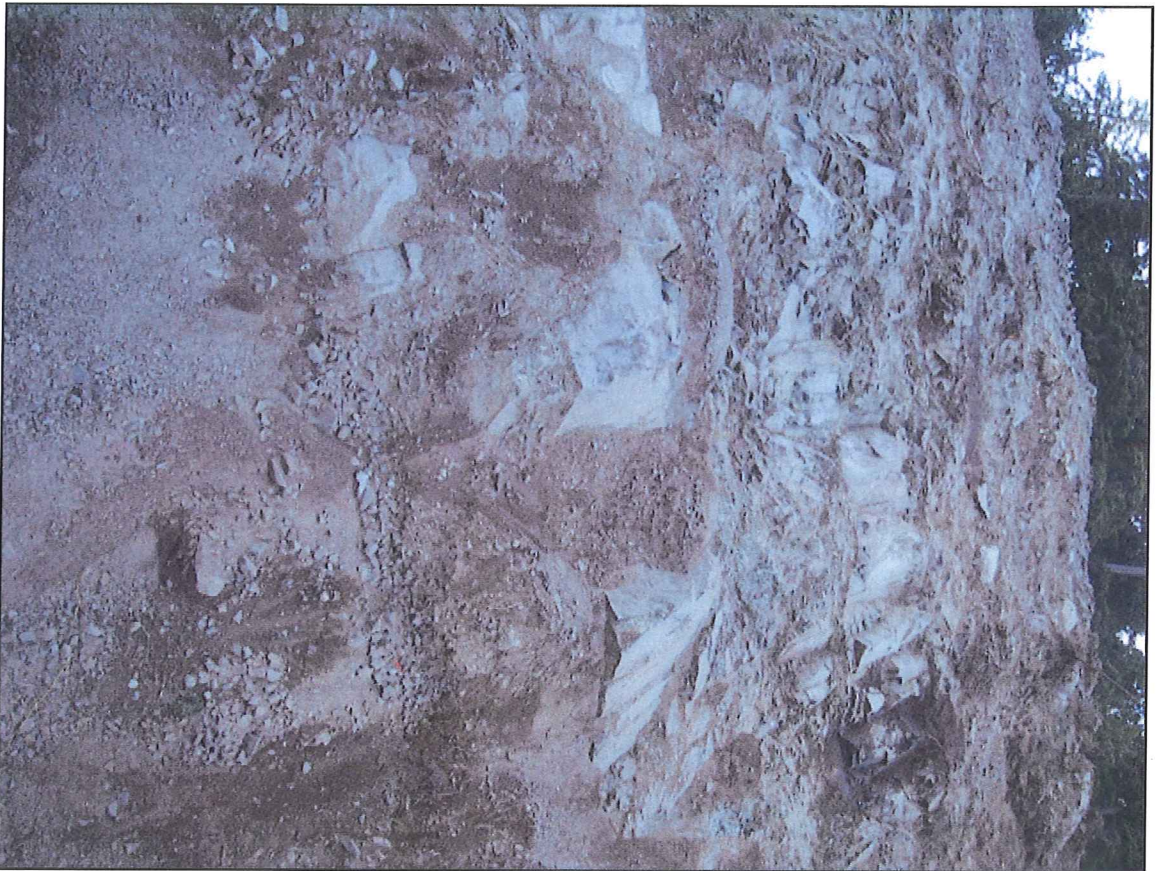
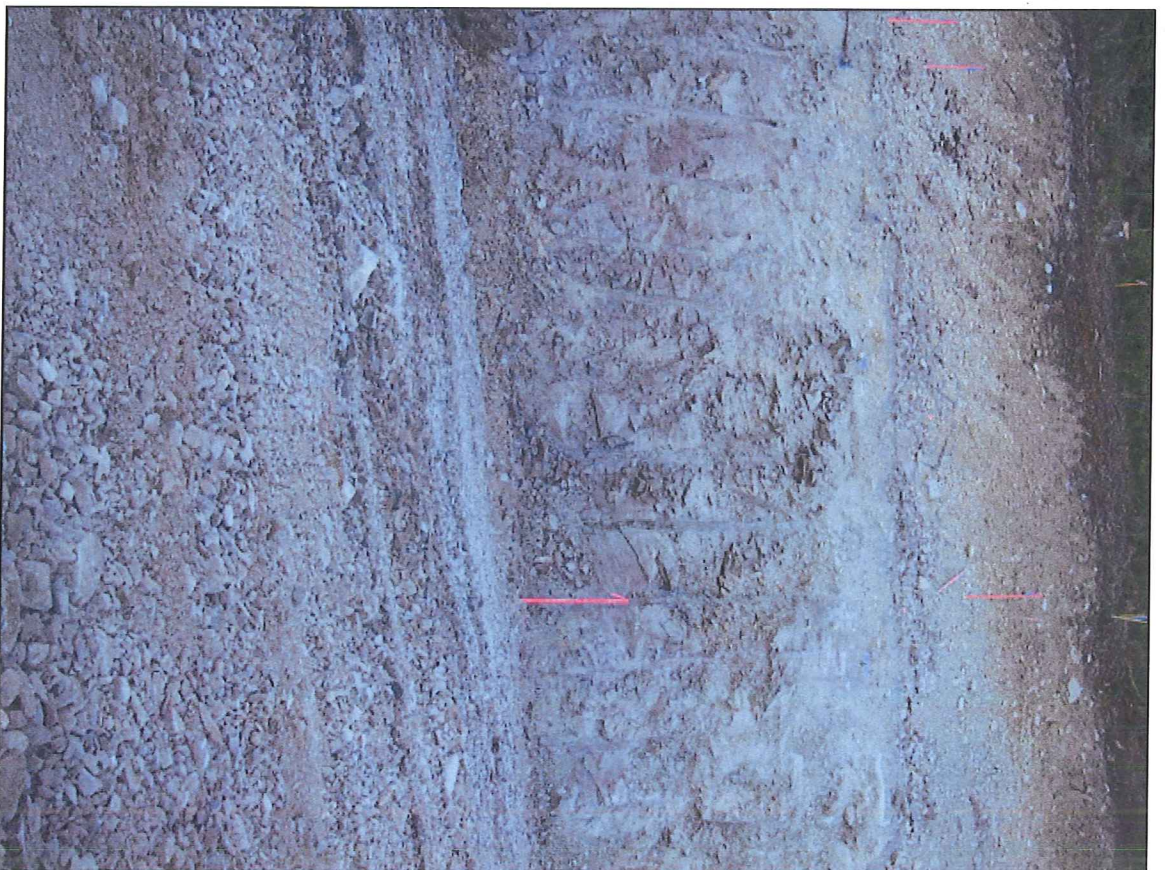
At Tom Badger's request, I attempted to field locate test boring RKS-3508 (Sta. 13231+00 70 ft Left) in order to obtain its elevation and the current slope geometry near this area (i.e. hinge point & overburden thickness). I was not able to locate the test boring but I was able to photograph the existing slope (Figure 2). Also at Tom's request, I collected the existing bench elevations from the existing slope stakes between Stations 1323+00 and 1324+00. There are as follow:

Figure 2: View of current slope near Station 1321+00 from below and from the along bench.

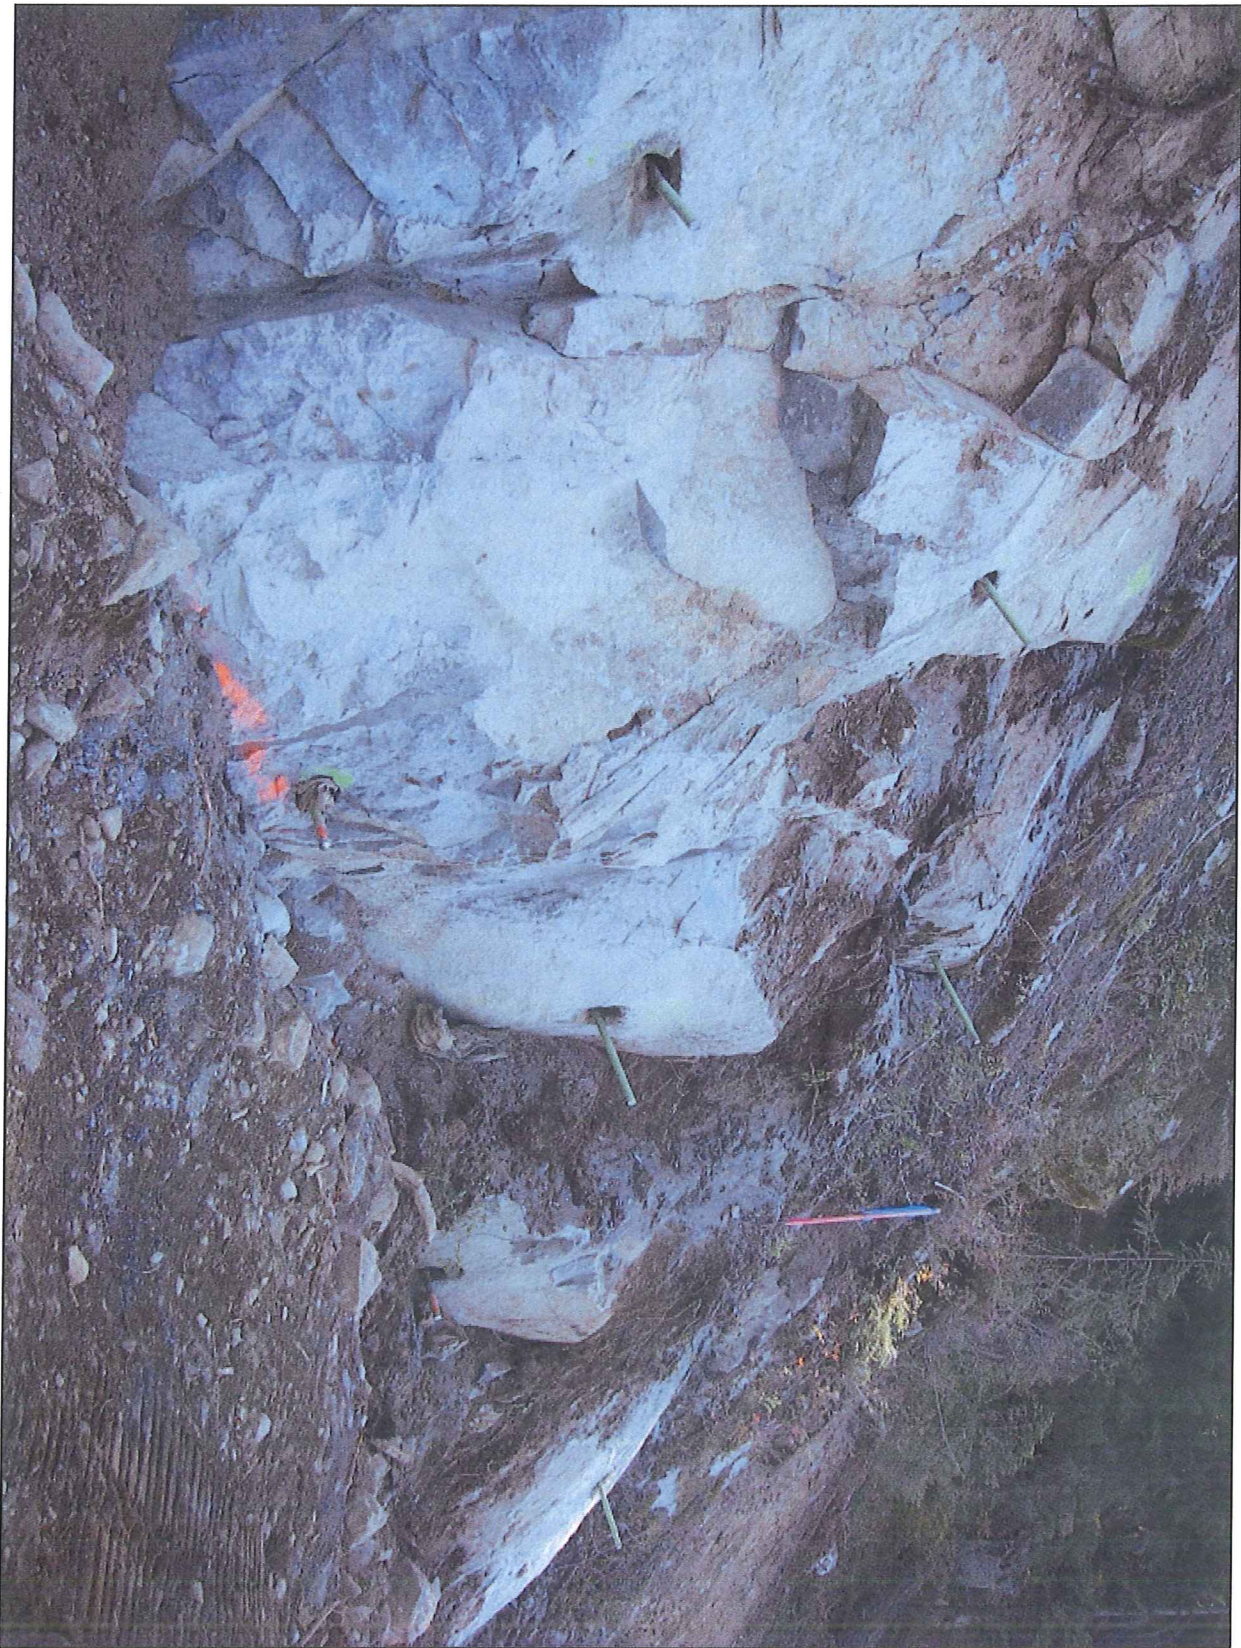
At Steve Lowell's request, I checked the status of the crest dowel installation between Stations 1333+50 and 1335+00. I found that the previously located crest dowels had been drilled, installed, and grouted (Figure 3). Also at Steve's request, I inspected the recently exposed cut face between Stations 1318+50 and 1321+00 and obtained geologic structure measurements and looked for a possible flow boundary. From approximate Stations 1318+70 to 1318+85 I observed a possible flow boundary between 6 and 18 inches wide containing reddish brown soft rock with clay/silt seams and seeping ground water. This possible flow boundary dives beneath the existing bench near Station 1318+85. Between Station 1318+85 and 1321+00, I observed thin (1/16 inch) clay/silt seams between small (~3 inch) fractured blocks of basalt and seeping ground water (Figures 4-6).

Figure 3: Crest and spot dowels installed near Station 1334+00.

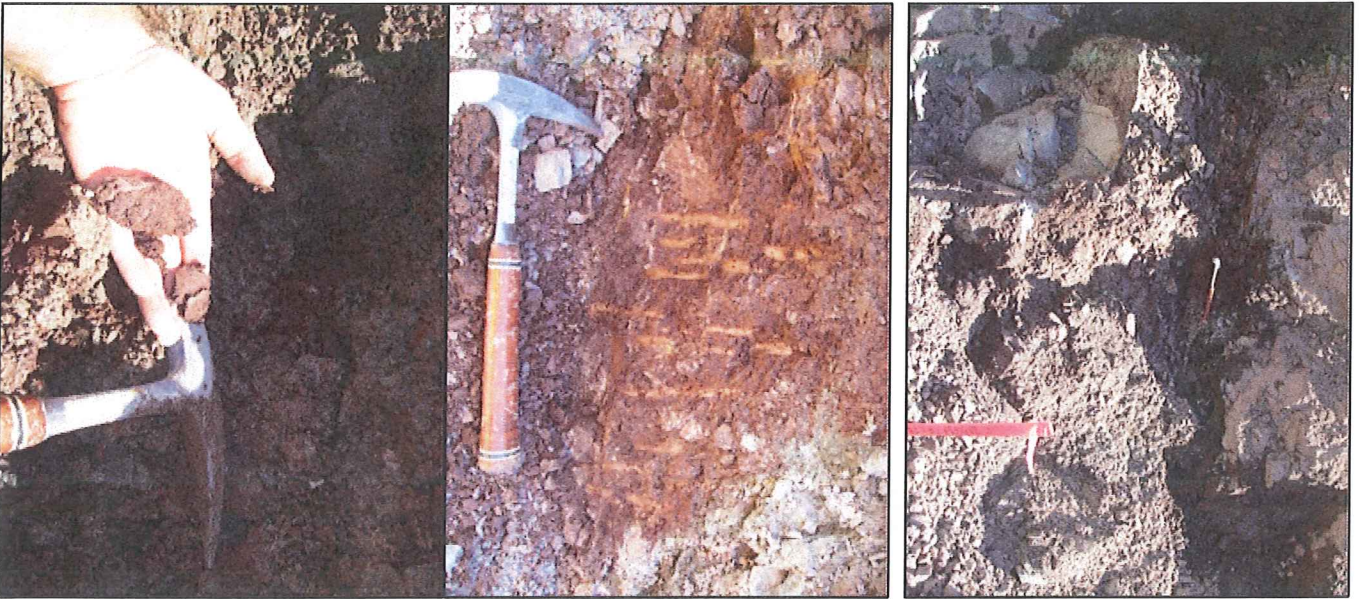
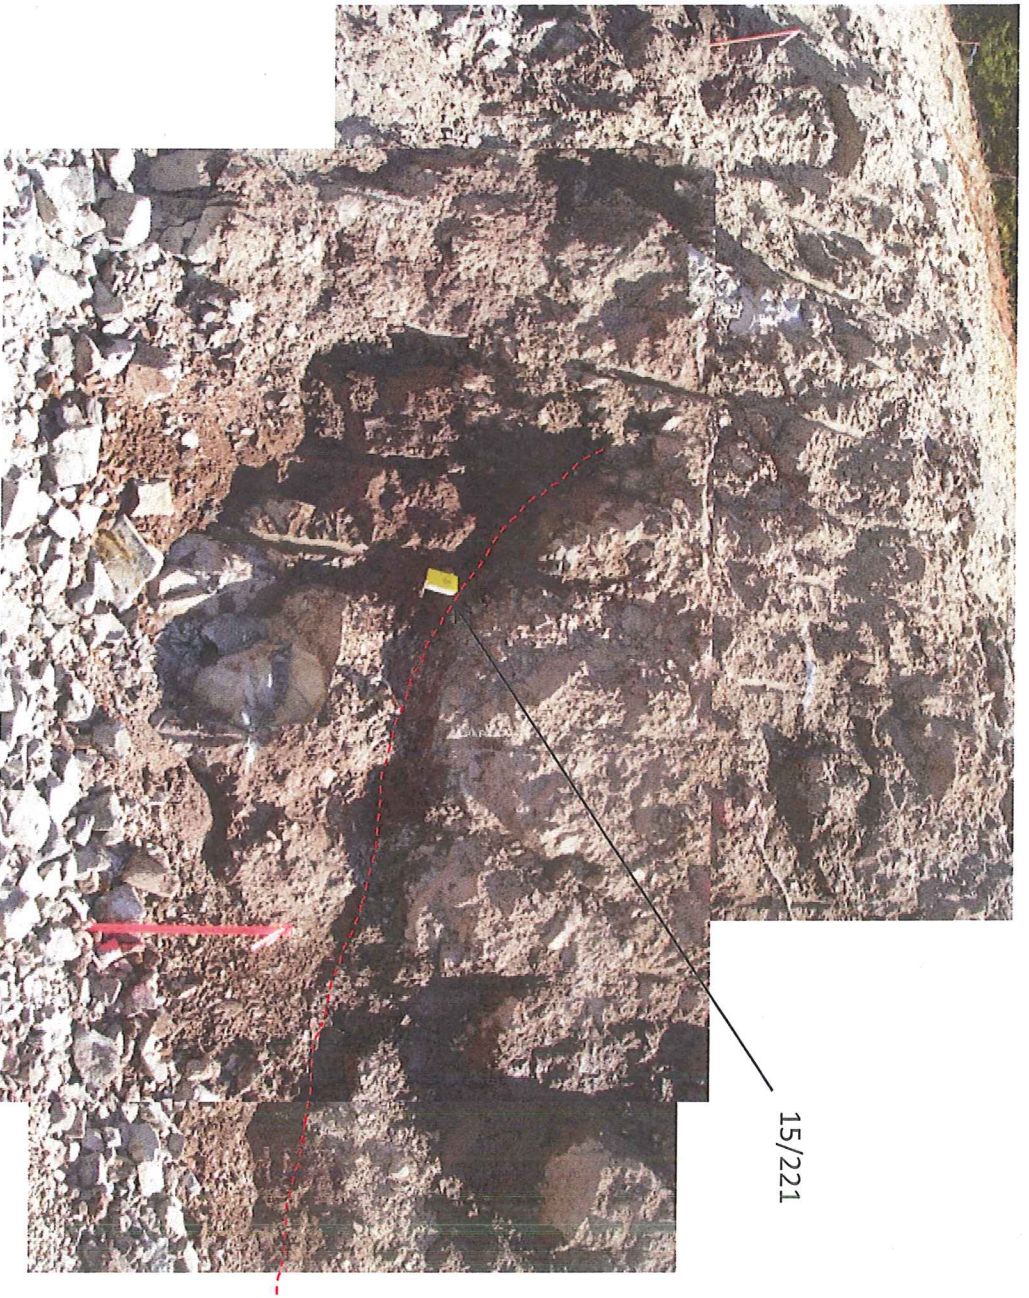
Figure 4: Sta. 1318+75: Possible flow boundary. The basaltic rock is soft reddish brown, weathered, with seeping water. Flow boundary is 6" to 18" thick. It dives below the bench near Sta. 1318+85 and rises upward near Sta. 1318+70.

15/178

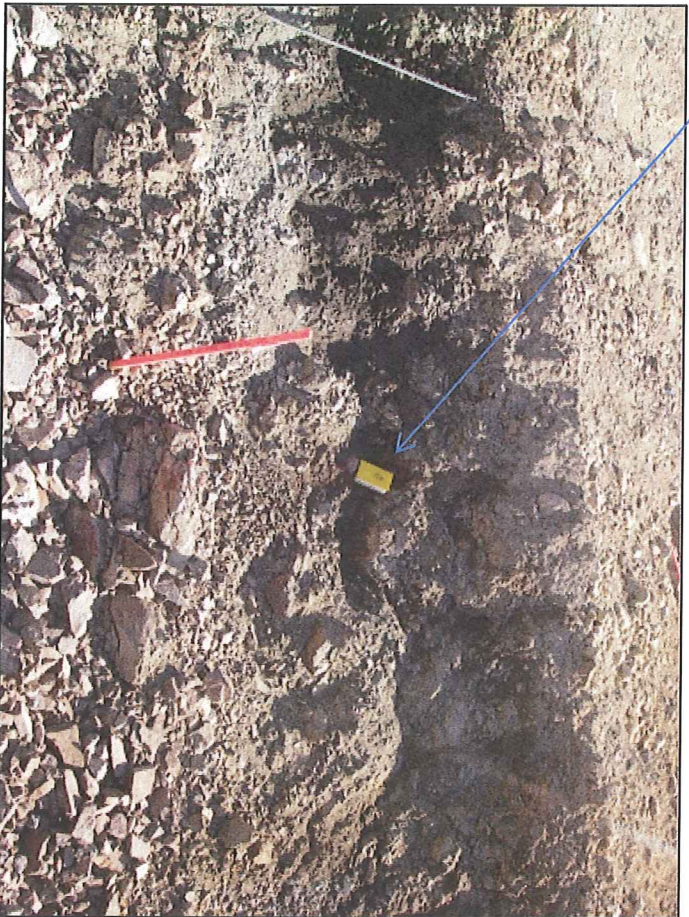
Sta. 1319+50

23/075

Between Stations 1320+00 to 1318+75 fracture apertures are tight to open with reddish brown clay/silt infilling and water.

Figure 5: Geologic structure and infilling, Stations 1319+00 to 1319+75

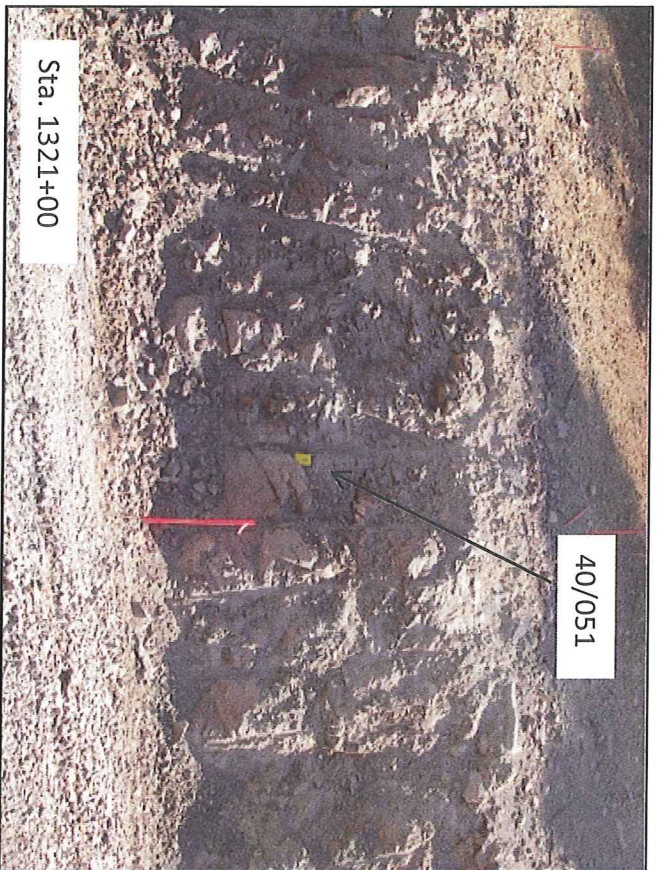
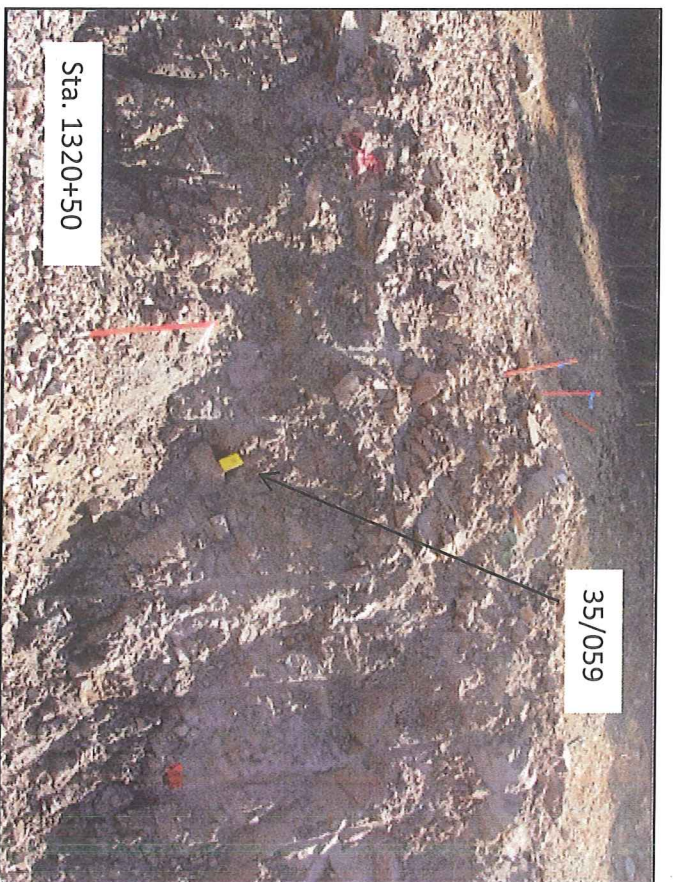
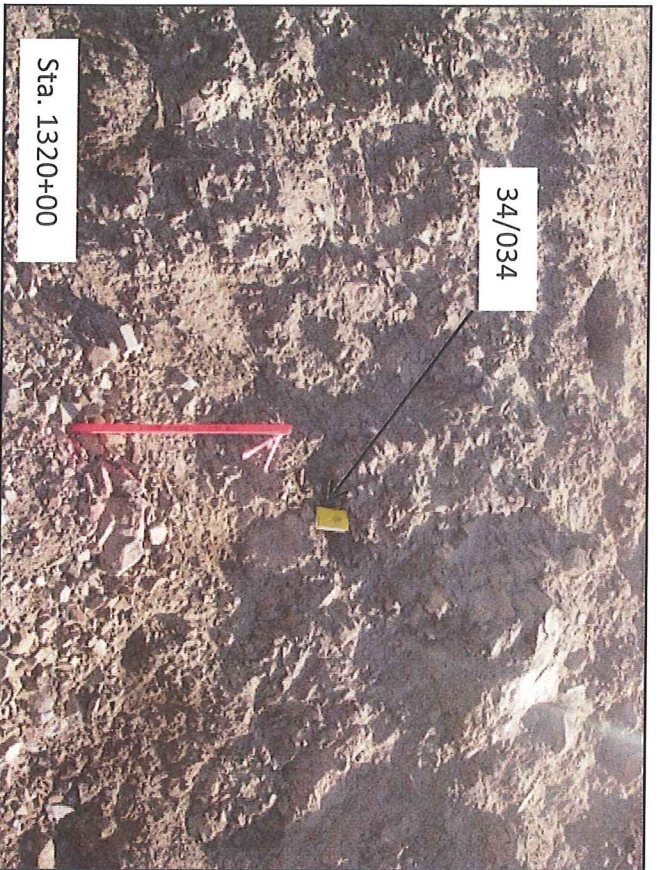
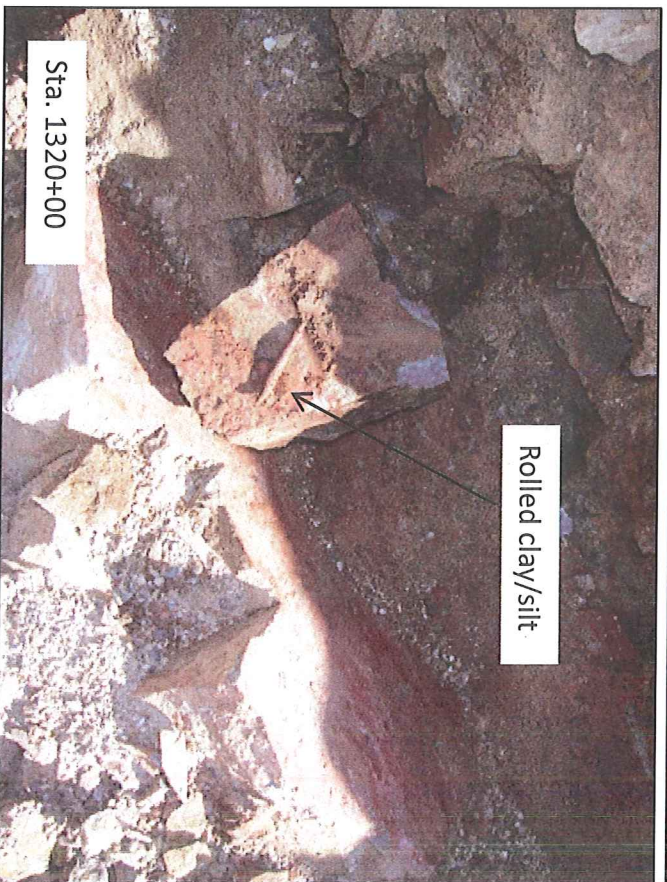
Figure 6: Geologic structure and infilling, Stations 1320+00 to 1321+00

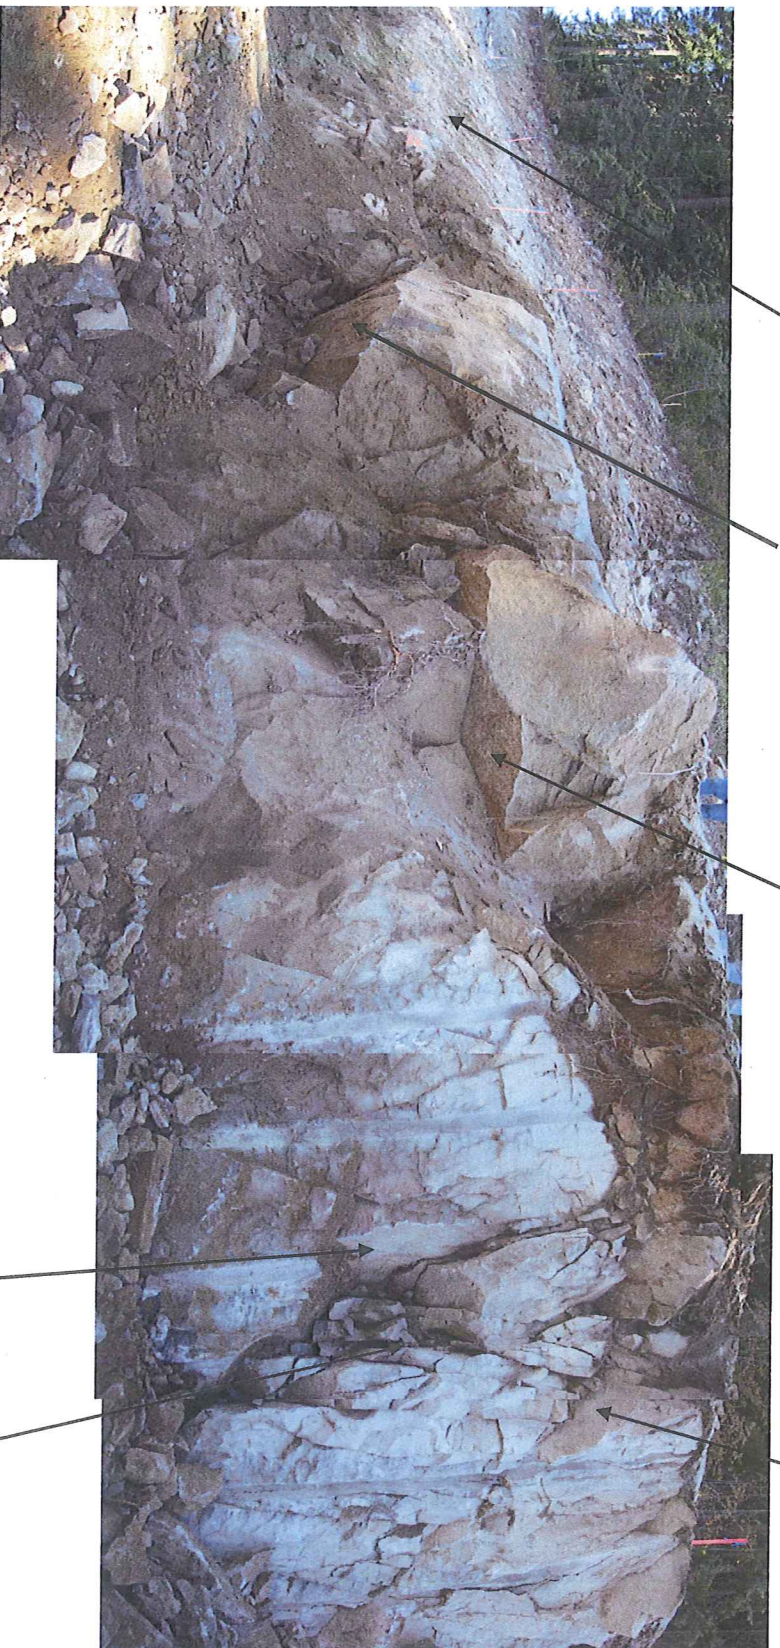
placed to the approximate Station 1339+40. These crest dowels had not been installed prior to blasting in the cut. I observed large (5 to 10 ft in diameter) detached blocks of lapilli tuff resting along the rock slope crest and other areas along the cut face with smaller (<2 ft in diameter) unstable blocks and soil. The slope was dry and the remaining half casts were approximately parallel and about 30 inches apart (Figures 7 & 8). I took several measurements of geologic structure, several photographs of the slope, and asked Brad to have the excavator operator attempt to nudge the large unstable blocks located along the rock slope crest. The large, potentially unstable blocks located along the slope crest could not be moved with the excavator. I marked several locations for crest and spot dowels along the face of the cut (Figure 9) and I left the project site and headed for my hotel at approximately 6:30 p.m.

Last crest dowel @ Sta. 1338+75

47/029

73/076. > 20 ft persistence  
back into slope. Possible  
toppling failure.

64/050

60/332

75/180 87/320

Figure 7: Slope cut face with geologic structural measurements and last crest dowel installed at Sta. 1338+75.

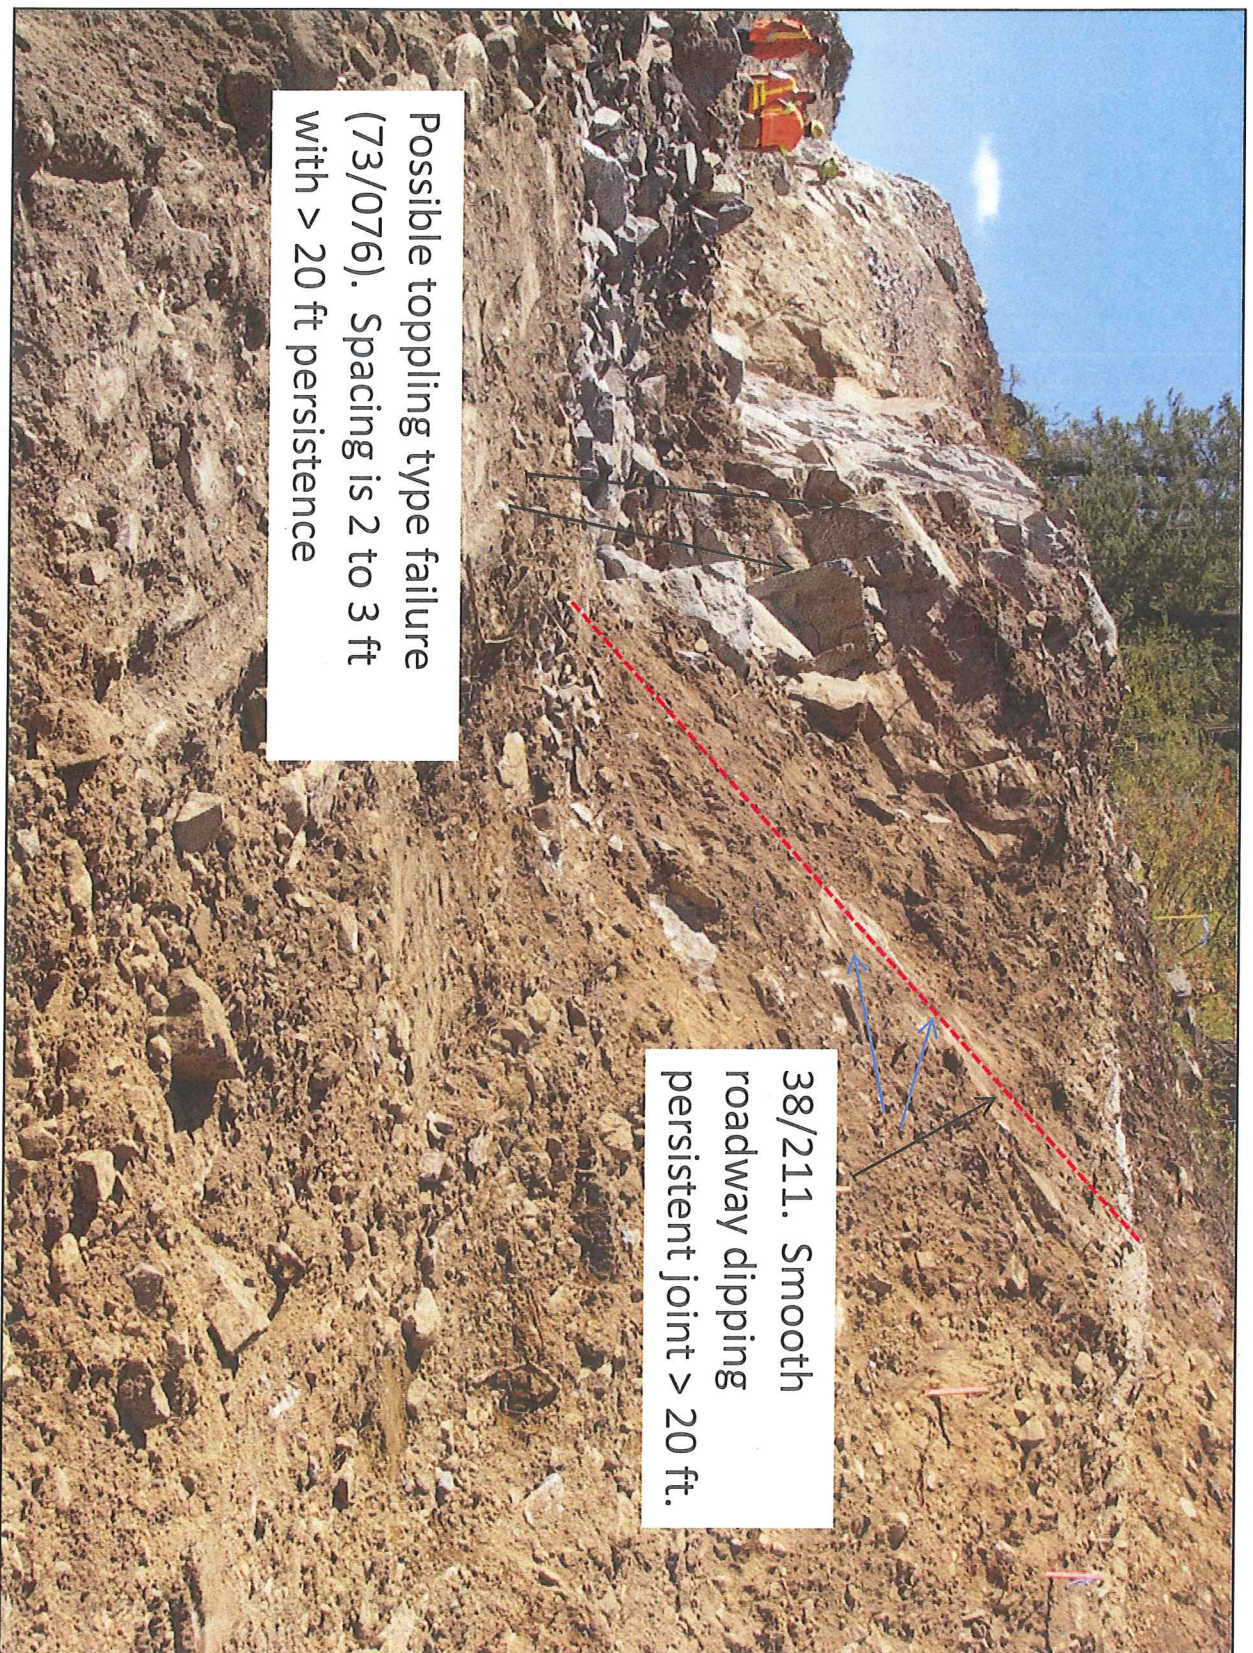
Possible toppling type failure  
(73/076). Spacing is 2 to 3 ft  
with > 20 ft persistence

38/211. Smooth  
roadway dipping  
persistent joint > 20 ft.

Figure 8: Possible toppling features and persistent roadway dipping plane.

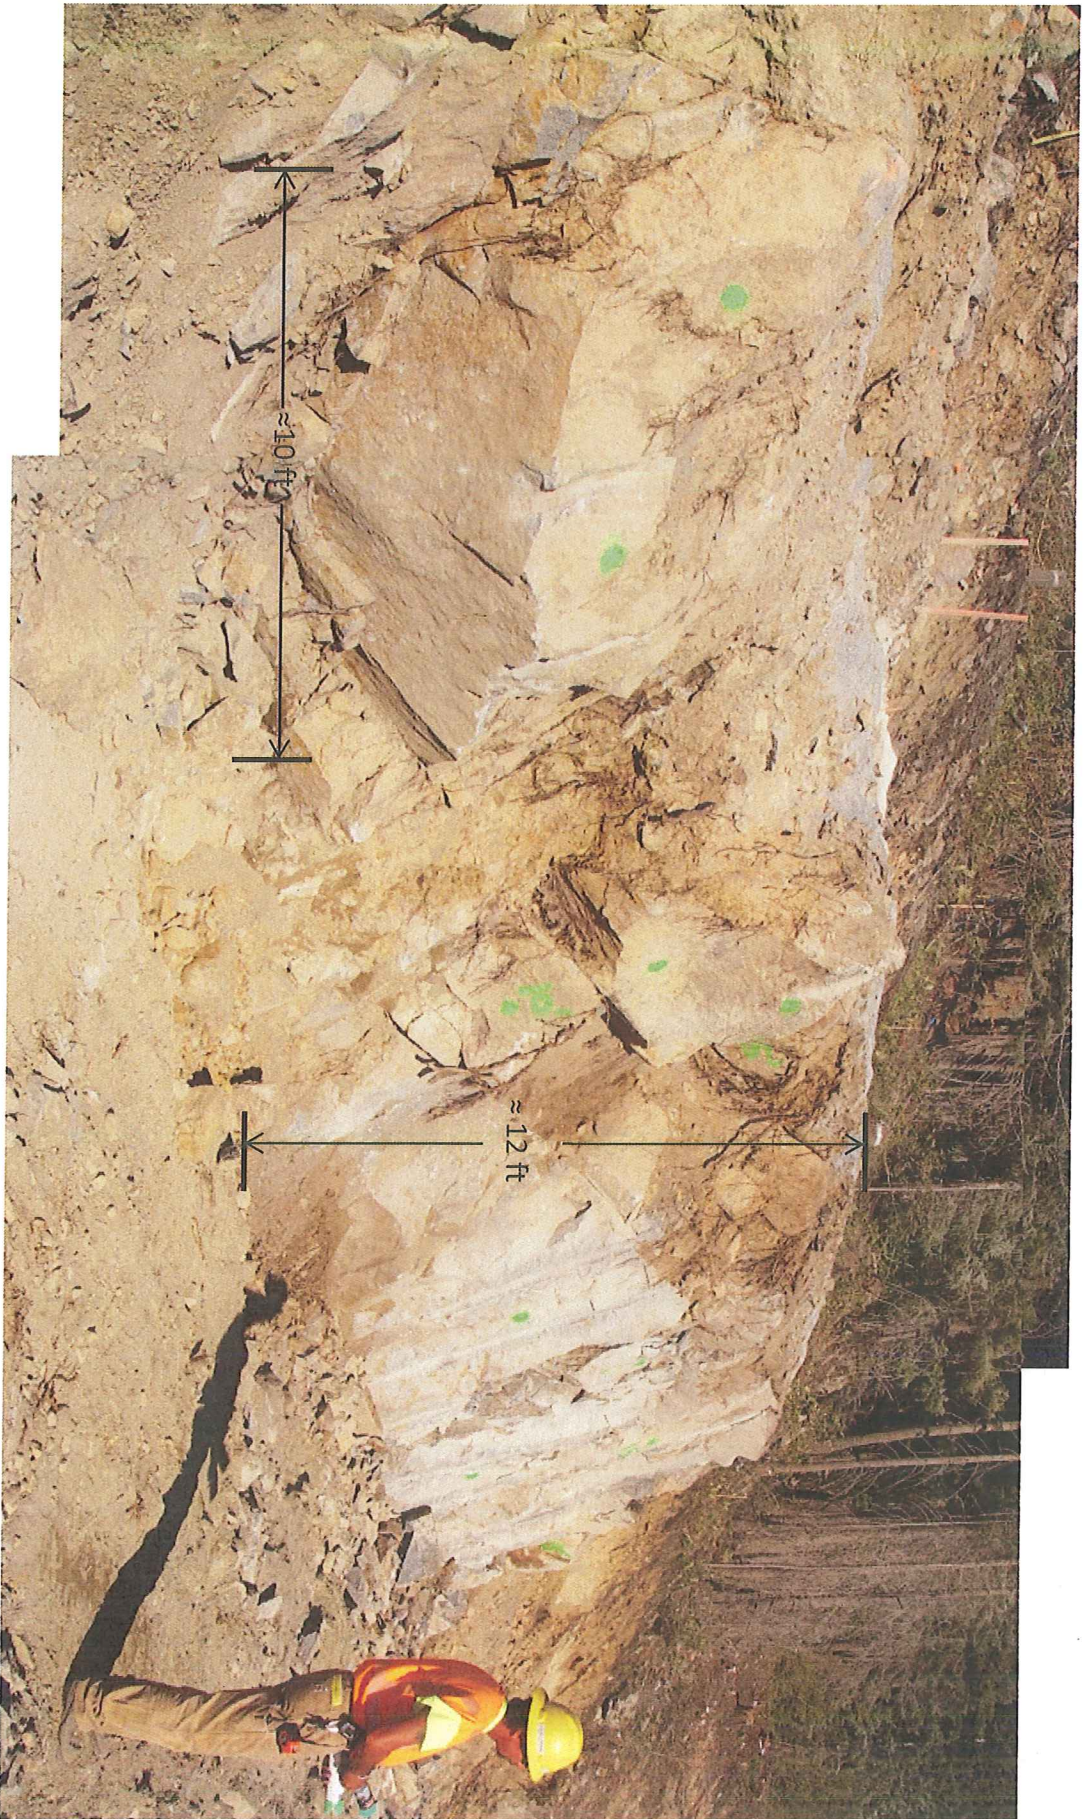
Figure 9: Preliminary stabilization, marked in the field between Sta. 1338+75 & 1339+40
